TROUBLESHOOTING & MAINTENANCE

Y34, Y1 or Y2 Yard Hydrant Packing Replacement

Rev 06/15 Form No. TMYH-1.104

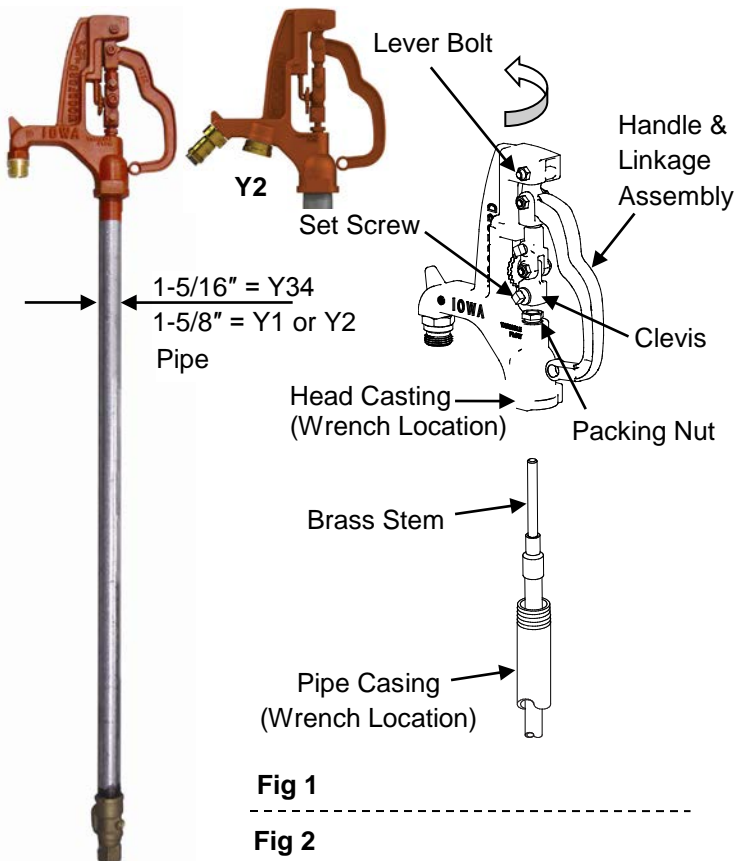
1. Shut off water supply to hydrant.
2. Loosen the Clevis Set Screw. Fig 1
3. Loosen, *do not remove*, the Packing Nut. Fig 1
4. Remove head casting using two pipe wrenches, one on head casting and the other on the pipe. Fig 1

5. Remove the Lever Bolt and remove and set aside the Handle and Linkage Assembly. Fig 1
6. Remove the Packing Nut. Fig 2
7. Dig out the graphite Packing with a screwdriver or other instrument. **Note:** This operation will destroy the Packing and require a new Packing #10101.

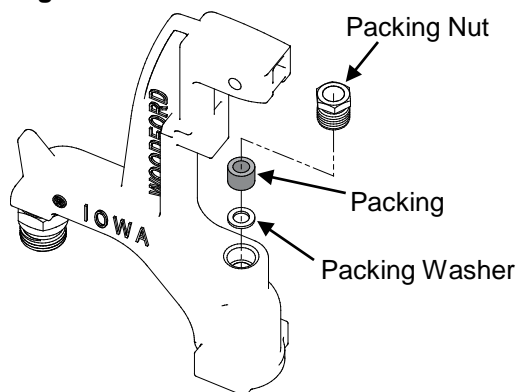
Fig 2

8. The Packing Washer #10102 may be reused.
9. Install new Packing #10101.
10. Reinstall the Packing Nut - do not tighten.
11. Reinstall the Handle and Linkage Assembly.
